NASA
Technical
Paper
3223

September 1992

Hot Fire Fatigue Testing Results for the Compliant Combustion Chamber

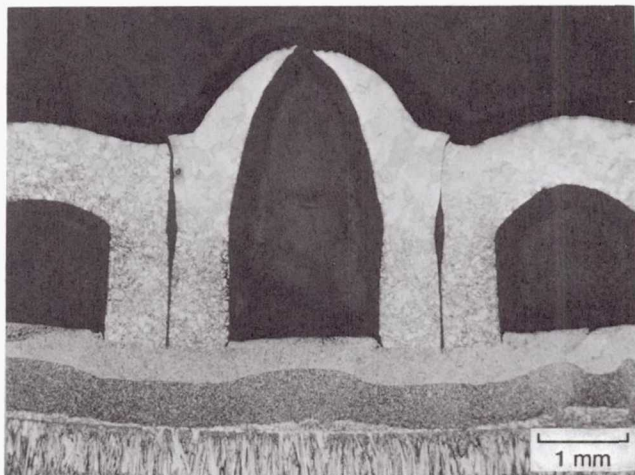
Figure 4.— Failure site.

The failure appears to be a pressure rupture caused by the insufficient strength of the OFHC (oxygen free, high conductivity) copper at excessively high temperatures. The absence of evidence of compressive cyclic yielding indicates that the failure was not of the type experienced on conventional milled-channel copper-alloy combustion chambers. It also indicates that the design feature of structural compliance provides significant improvement in chamber life. Figure 4 shows the failure site and the deformation in the two adjacent cooling passages. The failure occurred at the throat of the combustion chamber. Evident in figure 4 are two separate deformations. The first is the bulging of the cooling passage wall because of insufficient flexural strength. The second is the thinning, or necking down, of the rib tops because of insufficient tensile strength. Both of these deformations are caused by the cooling pressure force of 8224 kN/m^2 (1200 psia), and the yielding is caused by the reduced strength at the excessively high temperatures. The nature of the yield at the failure is clearly indicative of a purely tensile yielding with no evidence of any cyclically alternating tensile and compressive yielding.

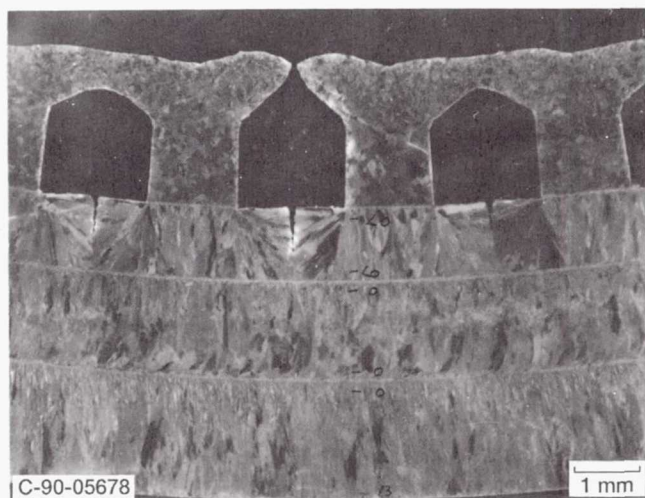
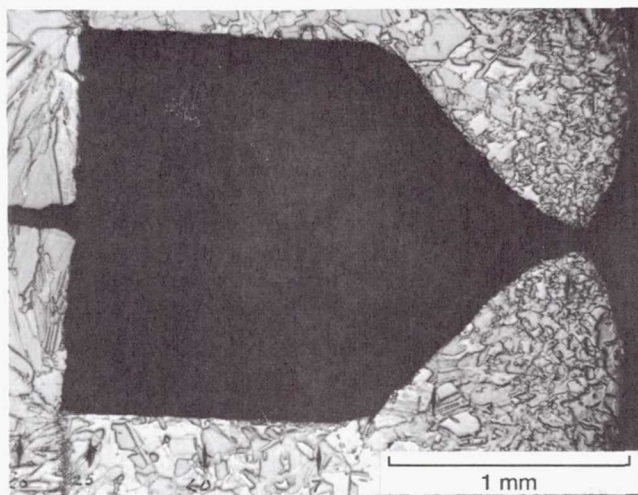
Figure 5.— Standard fatigue failure in OFHC copper liner.

Figure 6.— Grain structure of standard fatigue failure.

Cyclically alternating compressive and tensile yielding, called thermal ratcheting, is the scenario of typical standard chamber fatigue failures, as shown in figures 5 and 6. Its absence in the current case indicates the effectiveness of the structural compliance present in this configuration. Notice the blunt shape of the standard failure in figure 5 and the thickening of the wall material near the ribs as a result of material movement during the compressive yielding part of the cycle. Also notice the fine grain structure near the failure in figure 6. This is also the result of the material movement in the compressive direction causing grain structure breakup and strain hardening similar to a worked material.

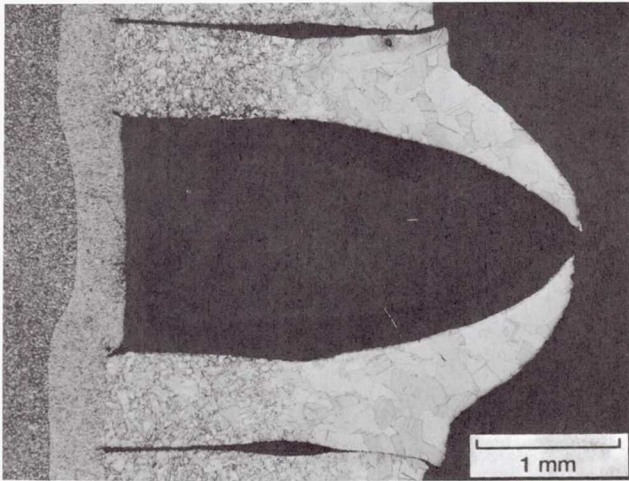
Figure 7.— Failure site.

Figure 7 shows the failure of the compliant chamber at a slightly higher magnification. Notice the variation in the grain size from the bottom to the top of the channel. The fine grain structure at the bottom is what the entire channel was

like before exposure to the hot-fire test environment. The larger grain size toward the top of the coolant channel is a result of grain growth caused by the excessive temperature during testing.

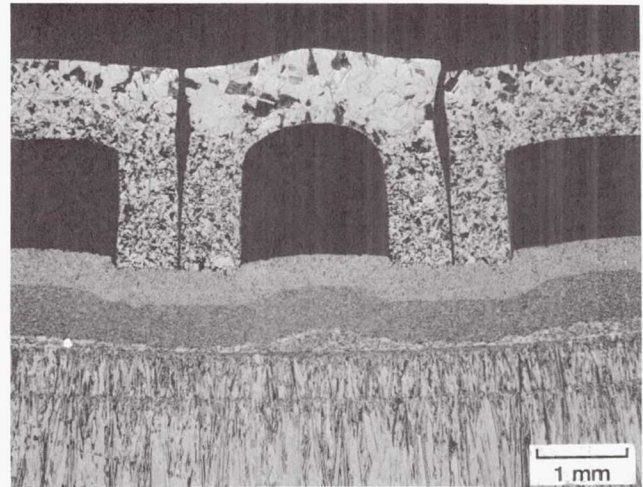
Figure 9.— 0.84 cm Upstream of failure site.

Another specimen was taken at 0.84 cm (0.33 in.) upstream of the failure site (throat). Figure 9 shows the etched specimen with the adjacent coolant channels. What is apparent is the lack of the severe distress evident in the previous specimens. This is what would be expected as the appearance of the throat specimen some time prior to the failure. Some plastic yield of a tensile nature is obvious, there is no evidence of any thermal ratcheting, and some evidence of grain growth is seen.

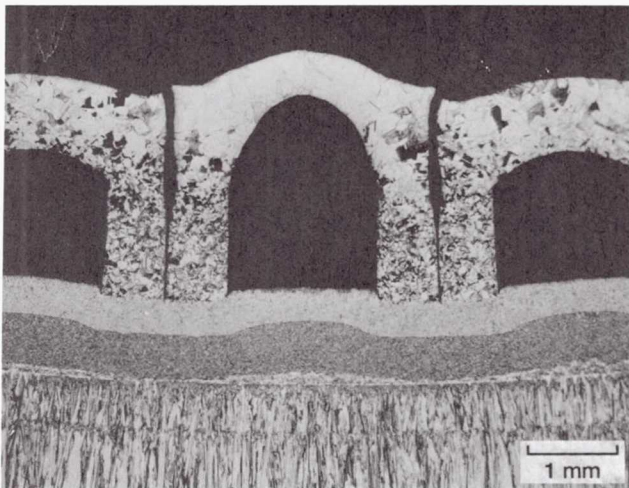
Figure 8.— 0.42 cm Upstream of failure site.

Figure 8 is a photomicrograph of an etched specimen taken 0.42 cm (0.16 in.) upstream of the throat (towards the injector). This is from the same channel that failed at the throat, but the specimen was taken from a location farther upstream in a slightly less severe heat environment. The condition of this specimen is also similar to what would have been expected at the failure site some time before the actual failure. As such, some insight can be gained as to the progression of the deformations towards failure. Notice the difference in grain size (growth) and structural deflection over the previous specimen. The heat-affected area is

smaller, although the apparent annealing at the top of the coolant passage seems just as severe.

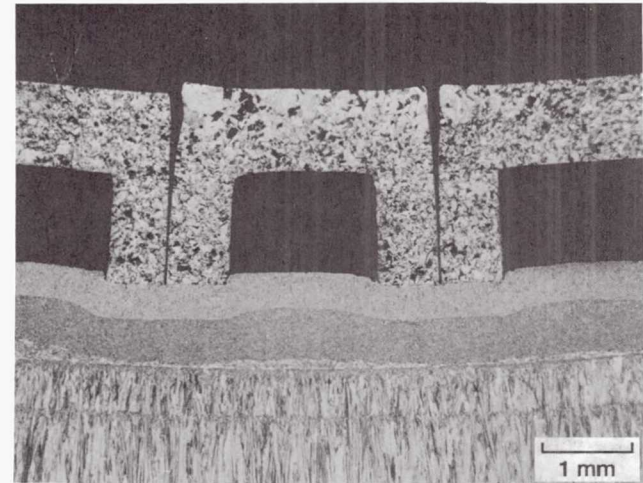
Figure 10.— 1.3 cm Upstream of failure site.

The next specimen (fig. 10), taken at a location 1.3 cm (0.5 in.) upstream of the throat location, shows only slight deflection and slight grain growth at the top of the coolant channel. Upward bulging as a result of the forces produced

by coolant pressure seem almost nonexistent. Notice the well-formed expansion gaps at the upper corners of the channels. These are the gaps that close on each cycle to form a smooth combustion side wall. It is evident that the self-design feature of these gaps was successful. The structural compliance feature seems also to be successful as there is no evidence of thermal ratcheting on any of the metallographic specimens.

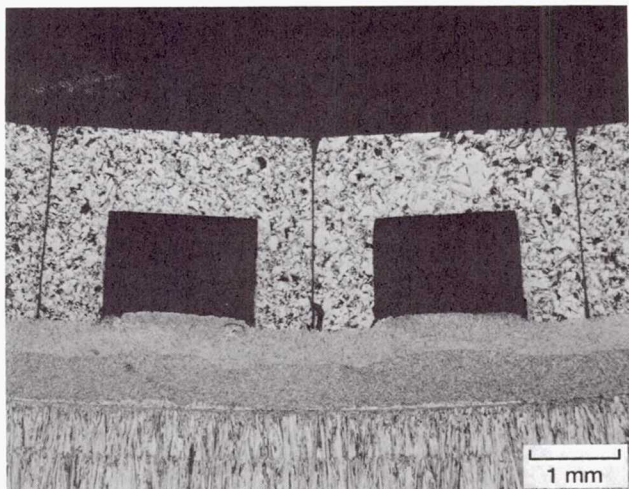
Figure 11. — 2.5 cm Upstream of failure site.

The final specimen was taken at a location of 2.5 cm (1.0 in.) upstream of the original failure site. Figure 11 shows the etched specimen at this location. The only evidence that this specimen was fired exists in the expansion gap that plastically formed during the first fire cycle. The expansion gap is considerably smaller on this specimen because of the less severe environment at this location. Lower heat fluxes cause less thermal expansion, and the required expansion gaps are smaller as a result. The grain structure of the specimen appears completely unaffected, with the grain size at the top looking the same as the grains at the bottom. This grain structure appears similar to what would be expected at the throat after only one cycle.

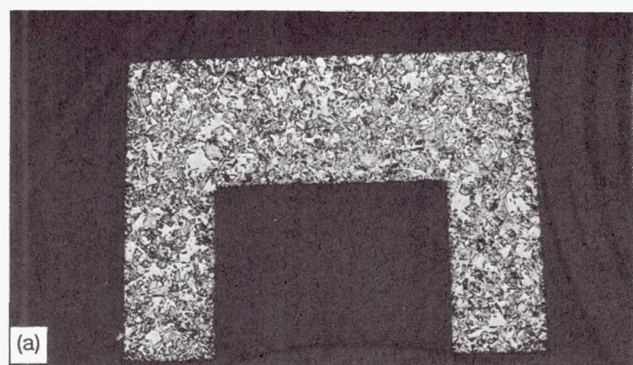
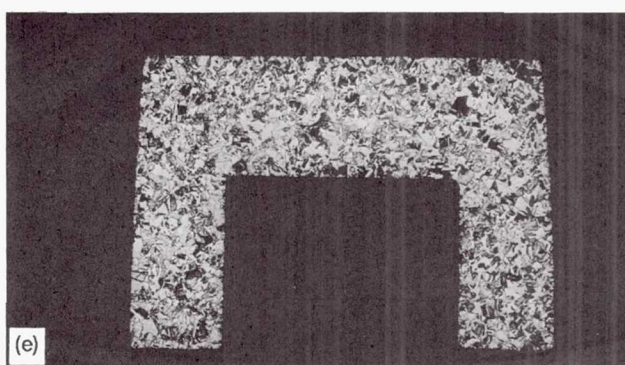
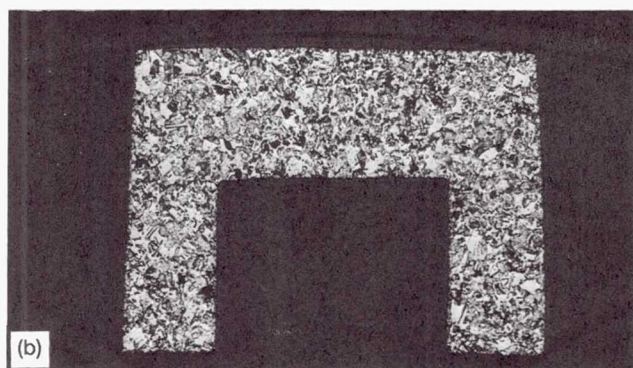
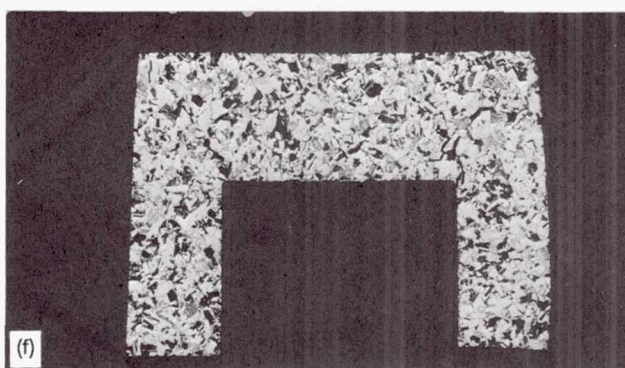
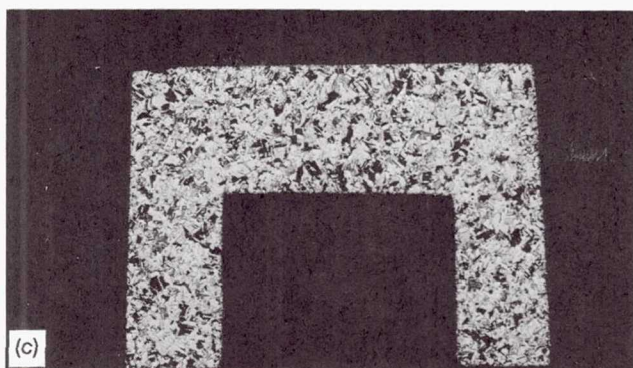
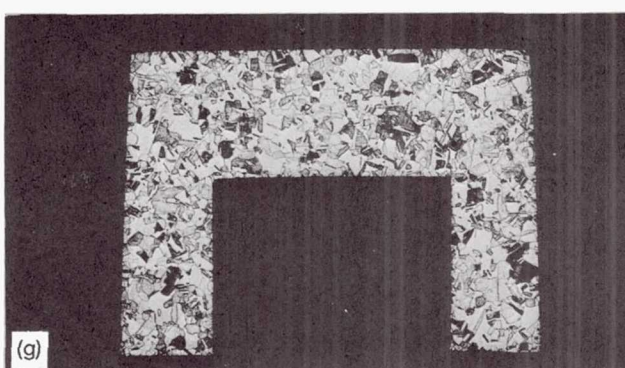
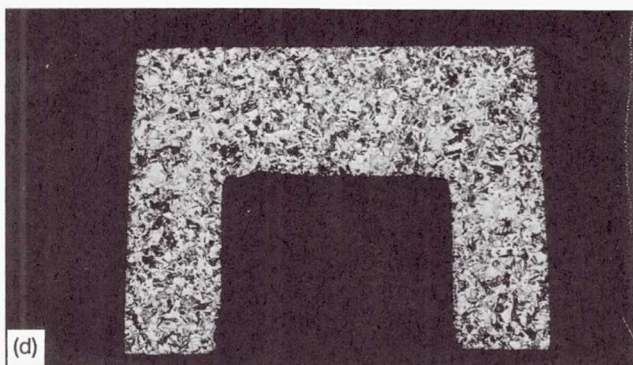
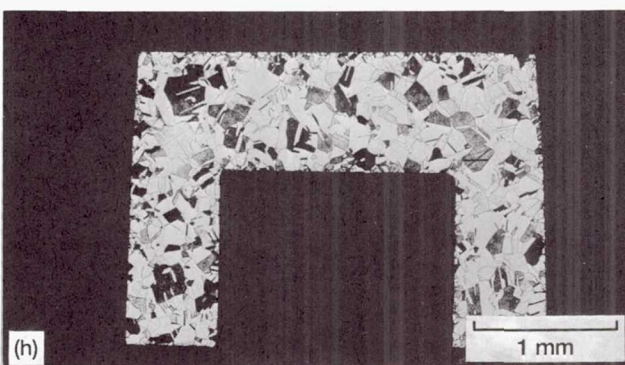
Figure 12.— Channel grain structures after 10-min anneal.

Figure 12 shows various annealed grain sizes for each of several temperatures. Figure 12(a) shows the as-received channel grain structure. (A magnification of 25 \times was used for all the annealing test specimens.) The annealing test was performed by heating the as-received channel material at temperatures varying from 315.5 to 760.0 $^{\circ}\text{C}$ (600 to 1400 $^{\circ}\text{F}$) for 10 min. The annealing time was selected as equivalent to the exposure time of the chamber channels during the hot-fire tests. Figures 12(b) to (h), photomicrographs of the annealed test specimens after polishing and etching, show the changes in grain structures. The specimens in parts (b) to (e) were annealed at 315.5 to 593.3 $^{\circ}\text{C}$ (600 to 1100 $^{\circ}\text{F}$) and show only slight, if any, grain growth. Parts (f) to (h), however, for specimens annealed at 648.9 to 760.0 $^{\circ}\text{C}$ (1200 to 1400 $^{\circ}\text{F}$), show a progressive increase in grain size. These figures were used to compare the grain size with that of the channel specimens taken from the fired chamber. This comparison shows that figure 7, which is at the failure site (throat area), has a larger grain size at the top of the channel than the figure 12(h) (760.0 $^{\circ}\text{C}$ anneal) grains. This indicates that the temperature at the top of the fired specimen was greater than 760.0 $^{\circ}\text{C}$ (1400 $^{\circ}\text{F}$). Figure 11, at a location of 0.42 cm (0.16 in.) upstream of the failure site, also shows a larger grain size at the top of the channel than does figure 12(h), again, indicating a temperature greater than 760.0 $^{\circ}\text{C}$ (1400 $^{\circ}\text{F}$). Only at 0.84 cm (0.33 in.) upstream of the failure site (fig. 9) do grain sizes approximate those shown in figure 12(h), indicating a region in the chamber where the wall temperature was about 760.0 $^{\circ}\text{C}$ (1400 $^{\circ}\text{F}$).

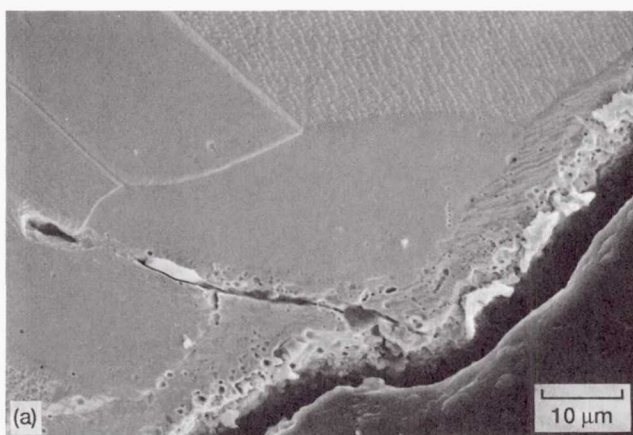
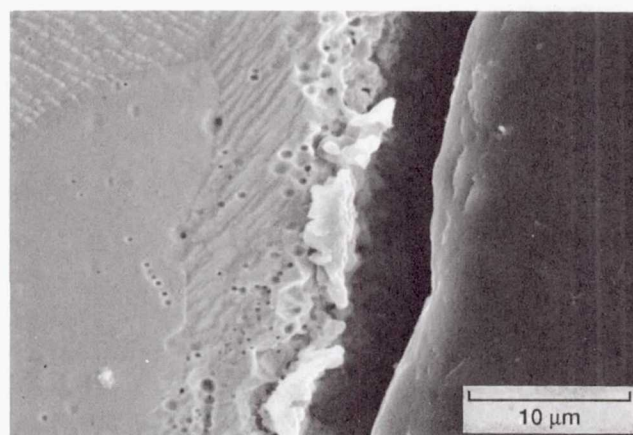
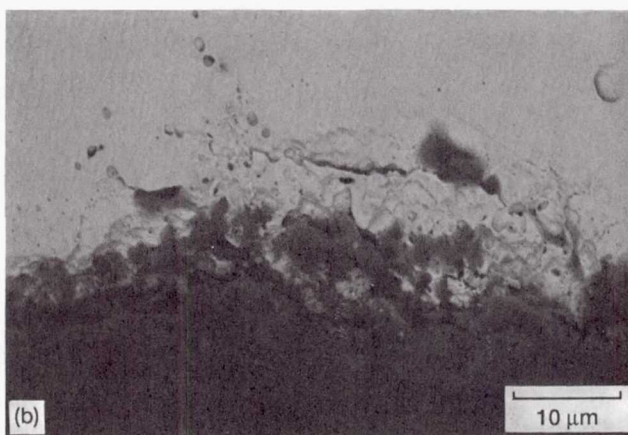
Figure 13.— Scanning electron microscope photographs.

In addition to metallography, several of the chamber specimens were analyzed using the scanning electron microscope (SEM). The SEM's (fig. 13) show that the hot-gas-side surfaces have considerable porosity and some recast copper. The porosity and recast copper indicate that temperatures in these areas were above 1083 $^{\circ}\text{C}$ (1981 $^{\circ}\text{F}$), the melting point of copper. These findings are similar to those reported in reference 8, thus providing further evidence that severe blanching of the channels had occurred. This reference is a study of blanching of copper combustion chambers. It includes data of gas-side wall temperature versus hot-gas-side wall roughness (in microinches), as well as porosity and surface melting of severely blanched copper.

(a) Secondary electron image showing molten area and porosity.
(b) Backscatter image showing surface melting at failure site.
